Manhole Inspection Summary

Manhole # S35GG_005MH

Location Address: **209 MOUNT ROYAL AVE**

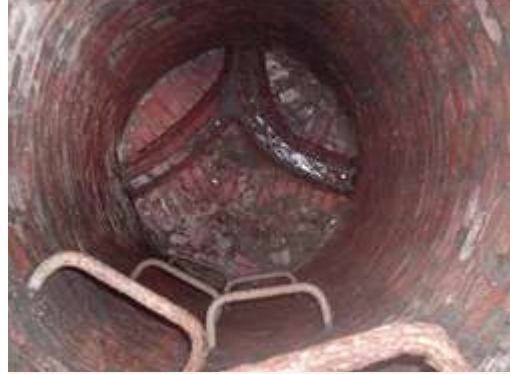
Top View

Corroded steps. Evidence of surcharge - Bench debris.

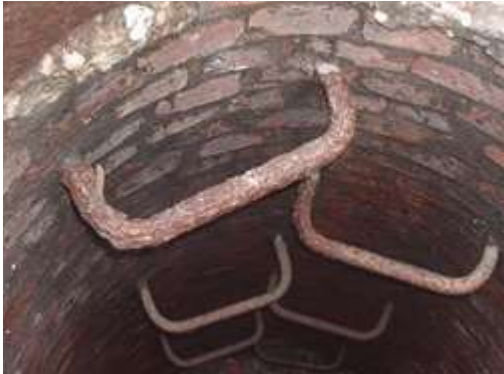
Defect

Adjustment deterioration and infiltration. Corbel infiltration.

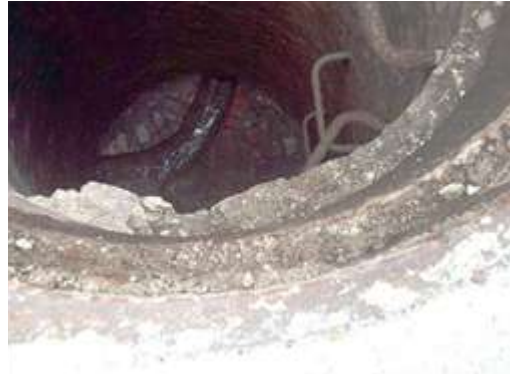
Defect

Frame offset.

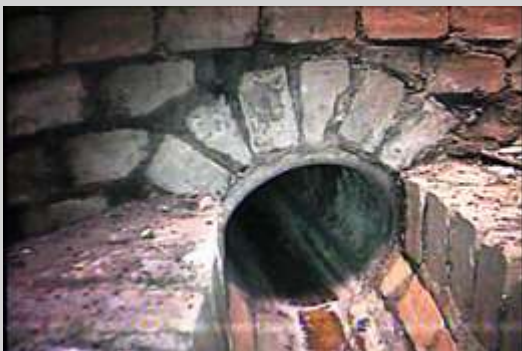
8 in. Circular Gravity Sewer Pipe In @ 3 O'Clock

Barrel deterioration and infiltration. Channel deterioration.

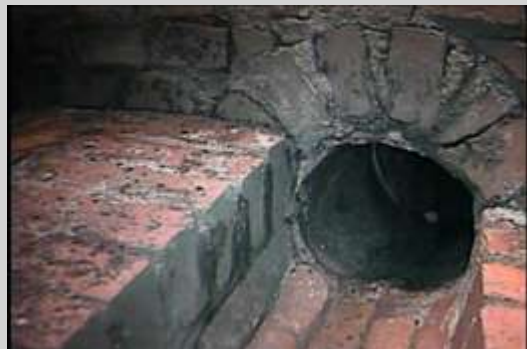
Pipe In @ 8 O'Clock

Barrel deterioration and infiltration. Channel deterioration.

Pipe Seal Cond: **Cracked**
